(6) National Dam Inspection Program.  
LAKE HENRY DAM  
(NDI ID <sup>Number</sup> PA-00366  
DER ID <sup>Number</sup> 35-16),  
~~PENNSYLVANIA GAS AND WATER COMPANY~~  
Susquehanna River Basin, Lake Run,  
Lackawanna County, Pennsylvania.  
PHASE I INSPECTION REPORT

LAKE HENRY DAM

NDI ID No. PA-00366  
DER ID No. 35-16

PHASE I INSPECTION REPORT  
NATIONAL DAM INSPECTION PROGRAM

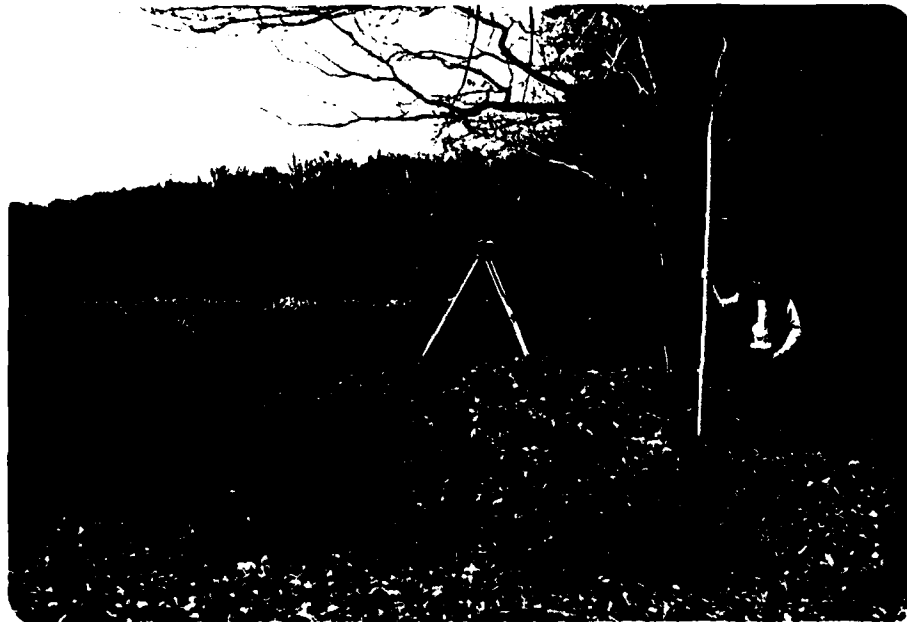
(2) Embankments. The low areas at the top of the embankments reduce the spillway discharge capacity. The low area of natural ground between the embankments will convey outflow before the embankments are overtopped. This may cause some erosion at the abutments of the embankments, and it is considered an erosion hazard. However, it is not felt that it would cause failure of the dam. Since the area acts as an auxiliary spillway, grading the area, clearing it of the minor amount of brush present, and protecting the ends of the embankments would appear to be warranted.

D. Low Area Between Embankments

- (3) Grade the low area between the embankments to provide better hydraulic control. Provide erosion protection at the abutments of both embankments.
- (4) Fill the hole at the end of the left embankment. Continue to observe the area. If changes are noted, take immediate remedial action.
